Wildfire Damage Assessment

Scotch Creek Hlina Lookout Trail
Mount Baldy Lookout Trail

Damage Assessment Overview

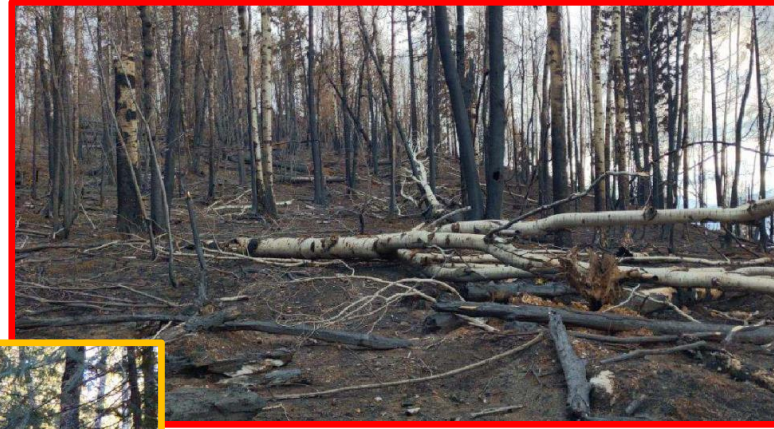
2 km for trail reconstruction

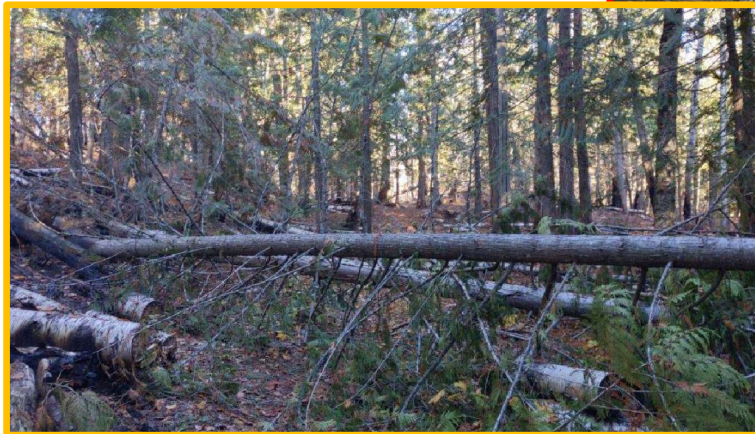
1 km for trail clean up

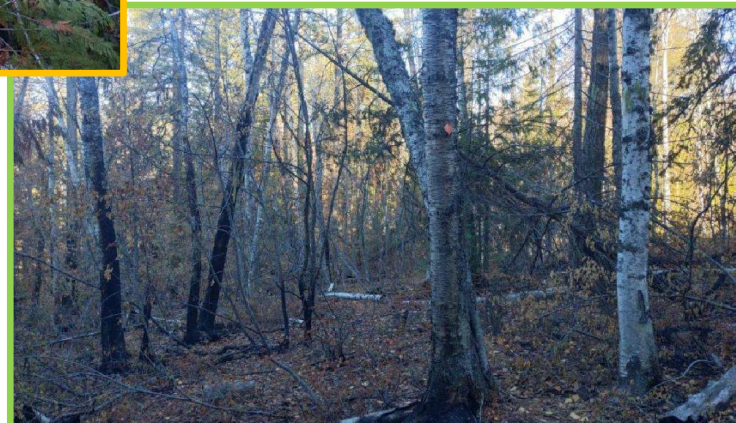
3 km no treatments needed

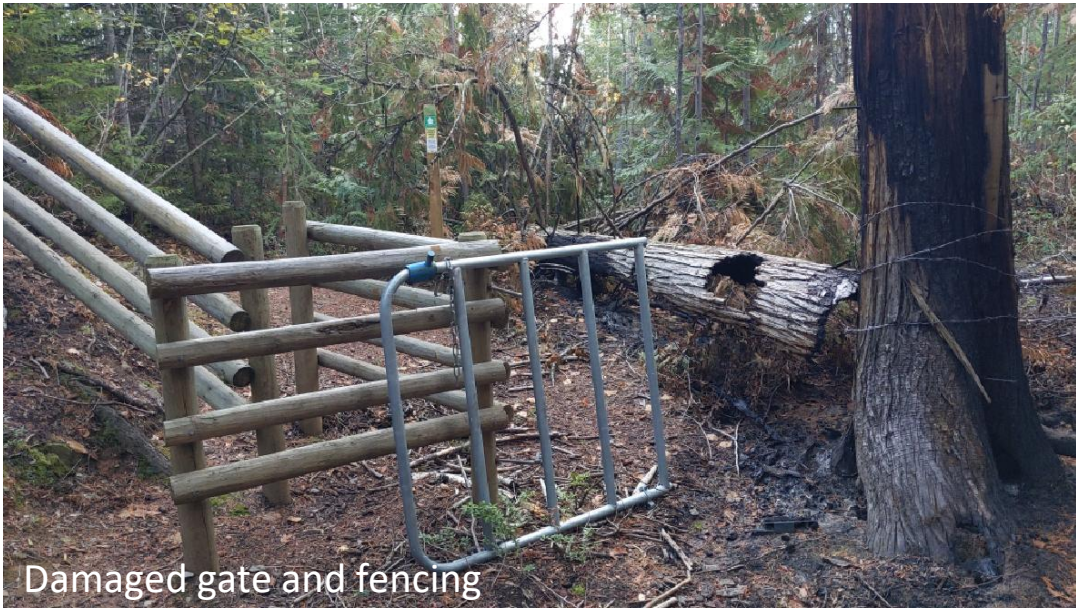
Damaged gate and fencing

- ❖ Danger Tree Assessments and Treatments, particularly near viewpoints
- ❖ Clearing trails of downed trees, vulnerability in gullies
- ❖ Replacing damaged boardwalks
- ❖ Consider possible new routes to avoid reconstruction on steep slopes
- ❖ Repair livestock fencing
