Wildfire Damage Assessment

Scotch Creek Hlina Lookout Trail
Mount Baldy Lookout Trail

Damage Assessment Overview

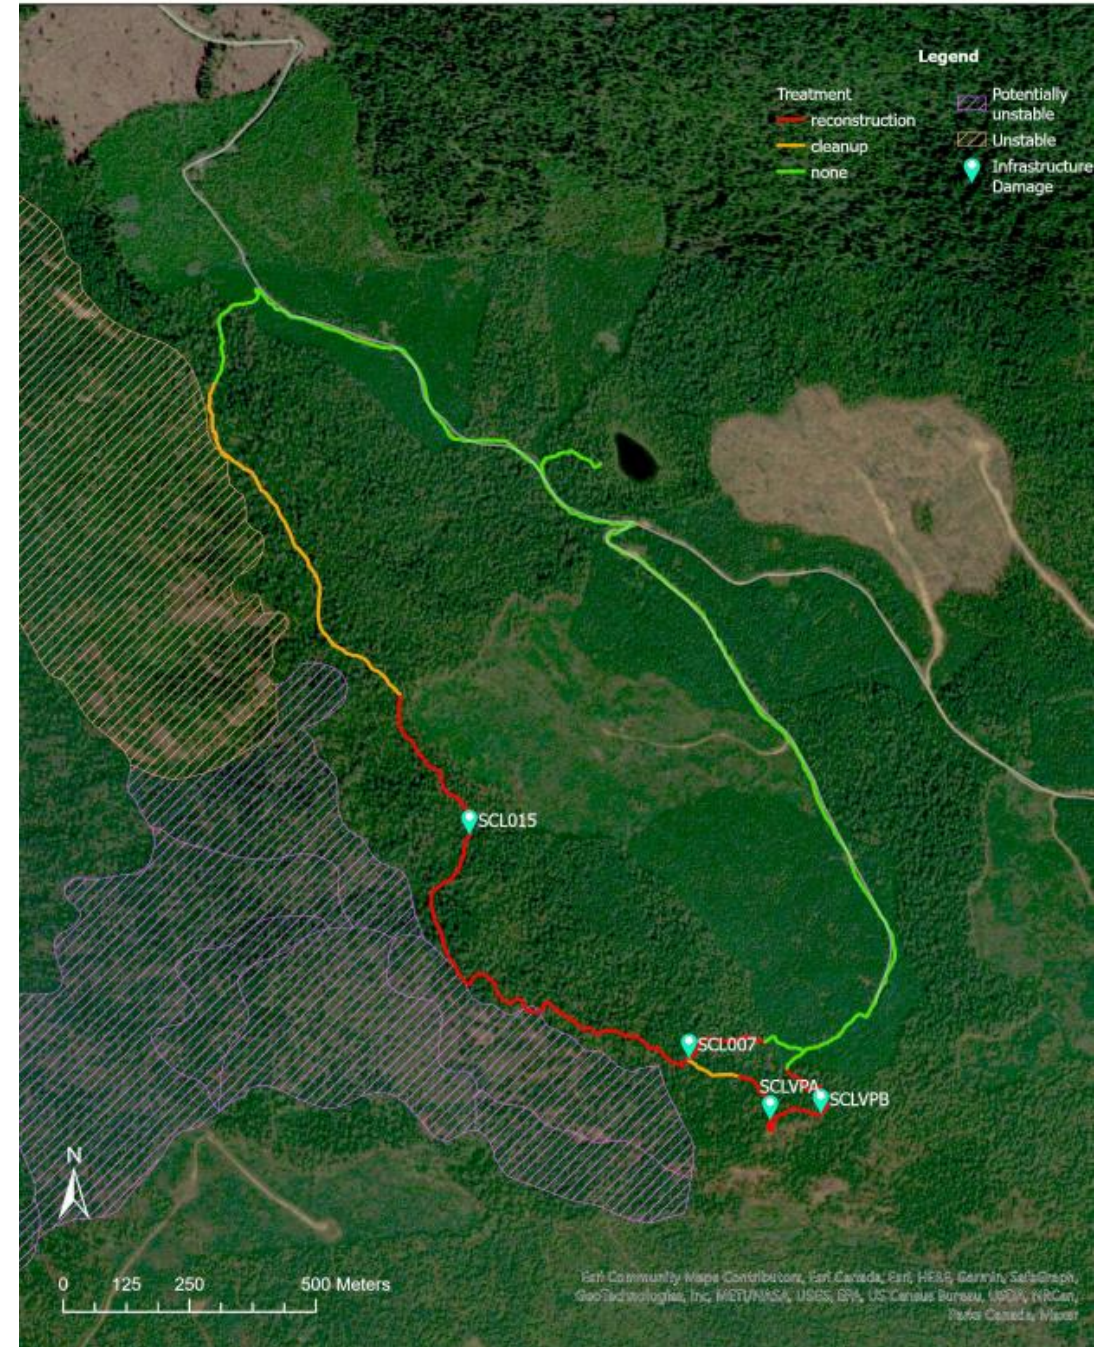
Scotch Creek Hlina Lookout Trail
Field Assessment - Trail Conditions and Hazards

Wildfire Trail Damage Results

2 km for trail reconstruction

1 km for trail clean up

3 km no treatments needed

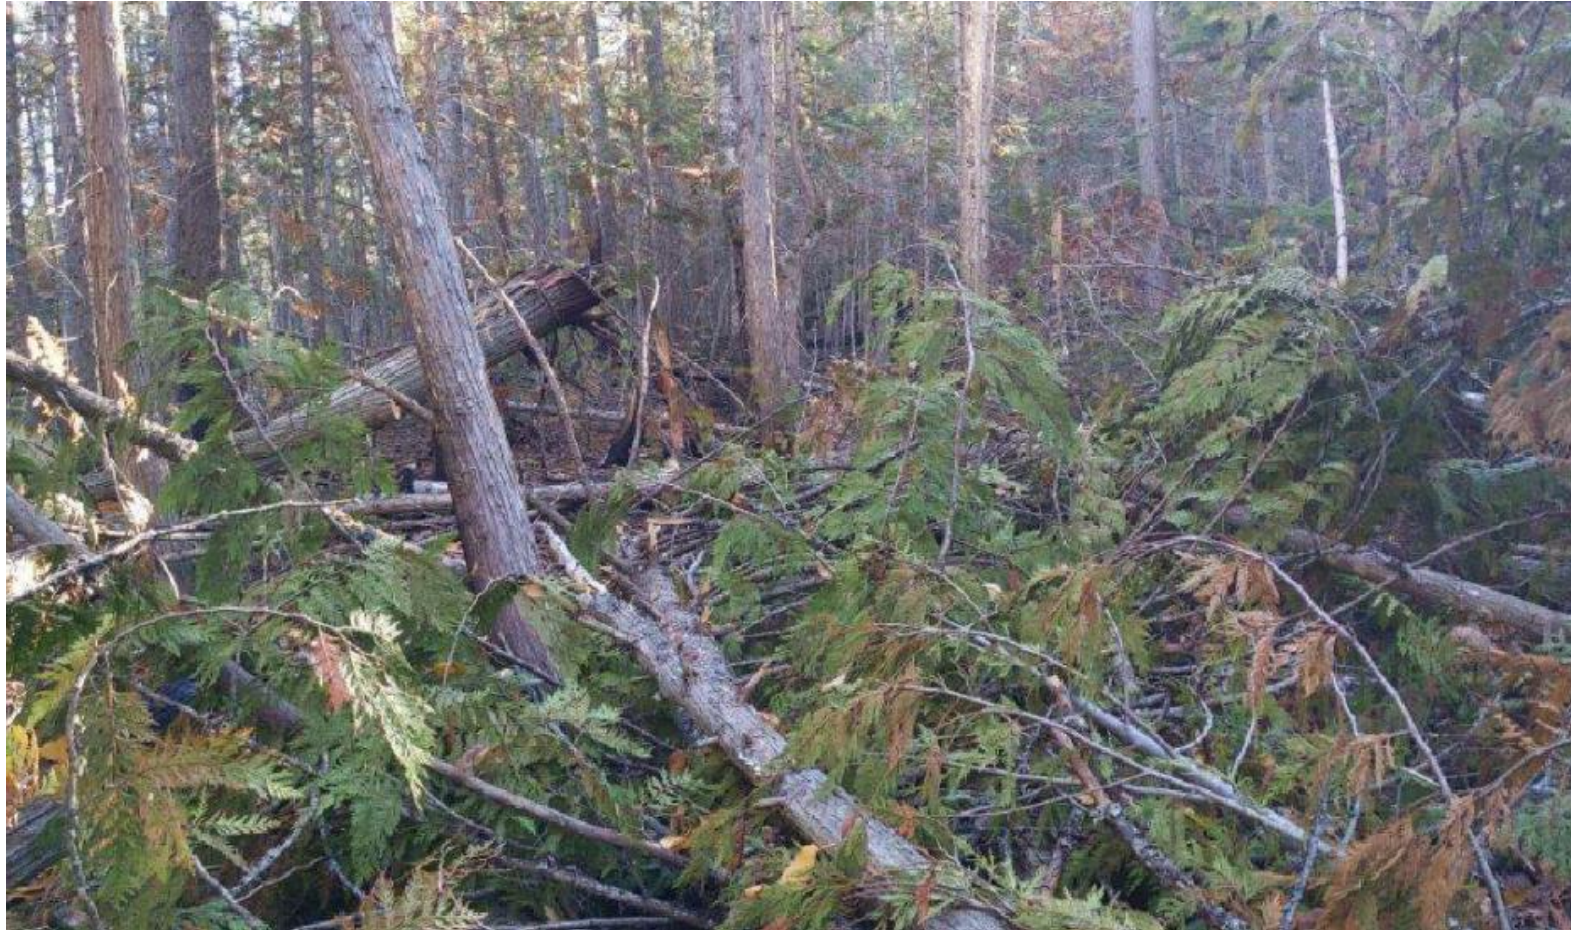
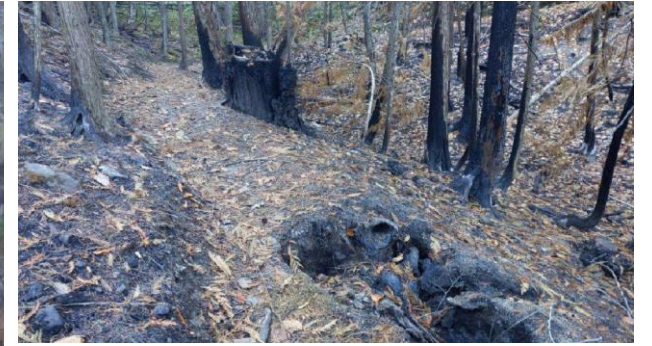
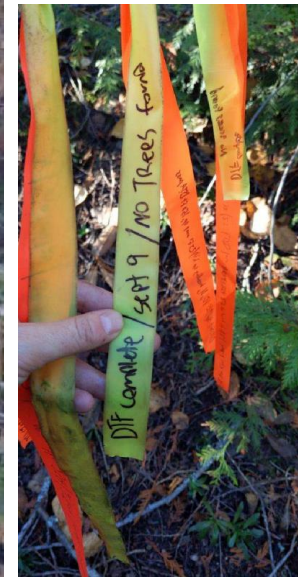
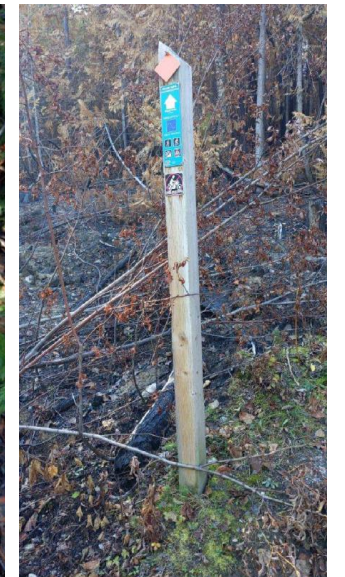
Mount Baldy Trail Field Assessment - Trail Conditions and Hazards

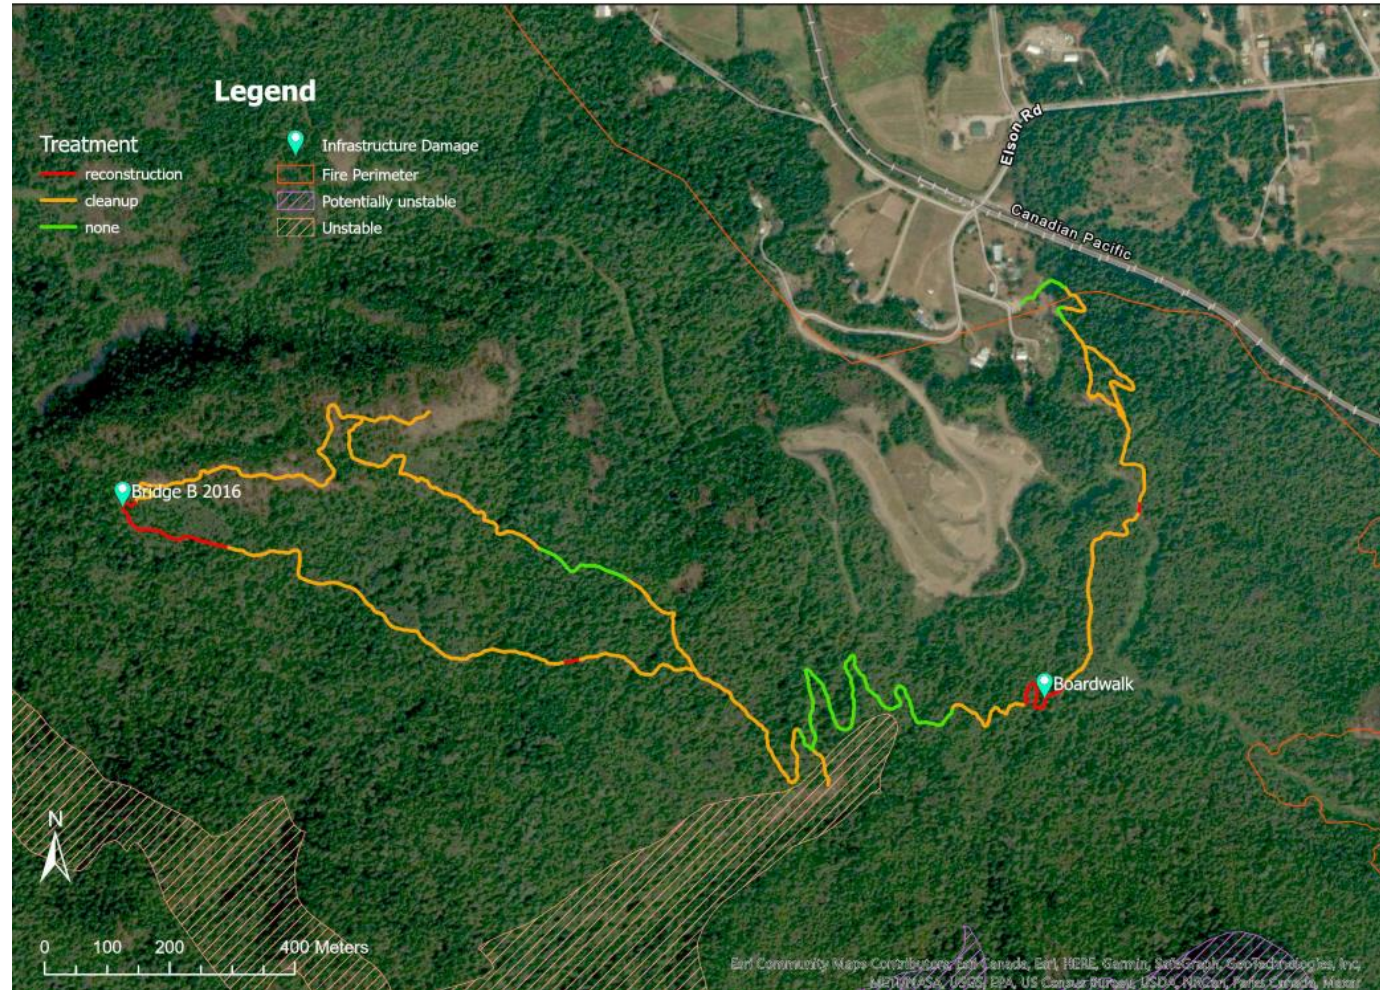
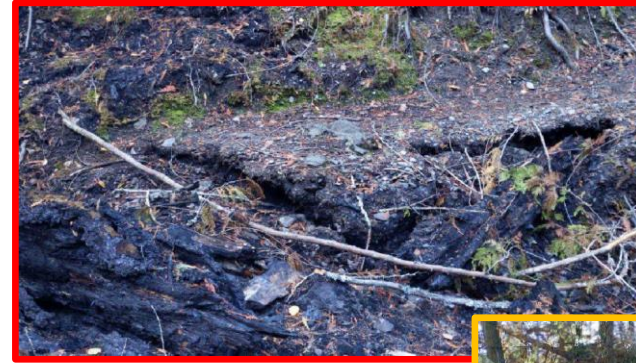
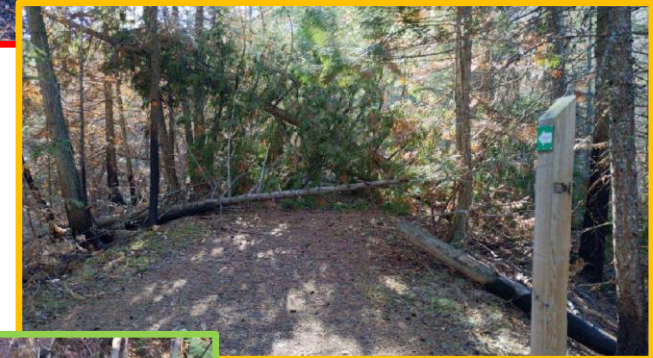
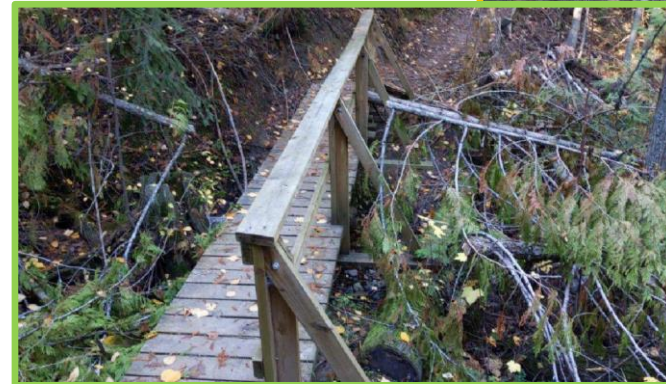
Mount Baldy Trail

Wildfire Trail Damage Results

- ❖ Danger Tree Assessments and Treatments, particularly near viewpoints
- ❖ Clearing trails of downed trees, vulnerability in gullies
- ❖ Replacing damaged boardwalks
- ❖ Consider possible new routes to avoid reconstruction on steep slopes
- ❖ Repair livestock fencing
